SWAN CREEK WATERSHED RIPARIAN AND HABITAT ASSESSMENT

A Report Prepared by Mark Lowdon M.Sc. AAE Tech Services Inc.

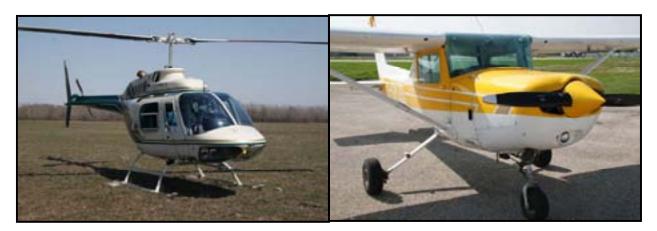
helicopter to be more cost effective. During both flights, a digital SLR Canon 30-D camera was used to take still images. Digital video was also recorded during both flights using a high definition 10.2-mega pixels Sony camcorder with image stabilization capabilities. To provide a track of the flight path a Garmin 60CSx GPS unit was used, recording waypoints (latitude and longitude coordinates) at one-second intervals. The photographs were then post-processed using a software program (GPS Photolink - standard edition) designed to link still images to their appropriate GPS coordinates by matching the time stamp produced by each device. In addition, the software program created files compatible with MapSource and ArcView software mapping programs, to allow one to display the flight path and linked photographs. Upon completion of the aerial surveys, identified potential rehabilitation sites were then subject to additional ground truthing surveys.

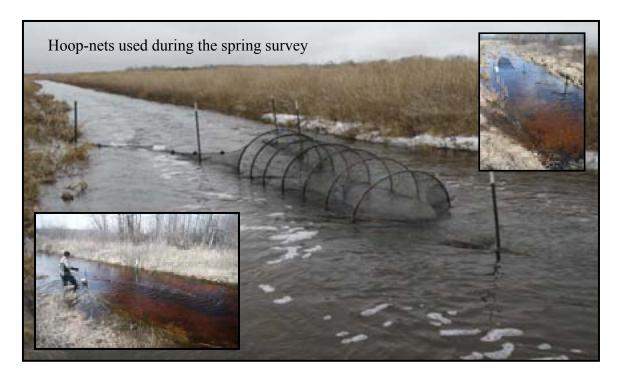
Dip netting, seining and conducting visual observations were additional methods used to assess fish utilization during the spring spawning migration during 2009.

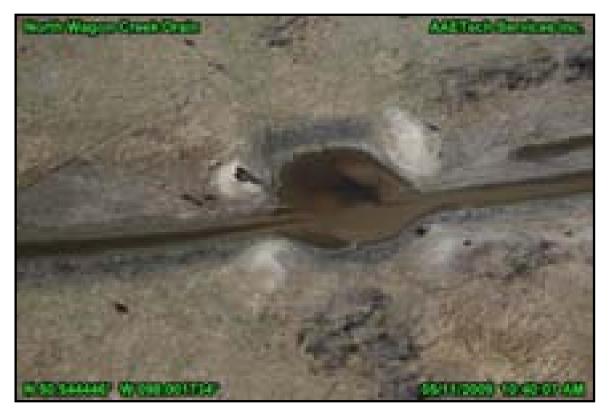
Figure 7. Livestock watering site on North Wagon Creek Drain (Characteristic of Class C habitat type)

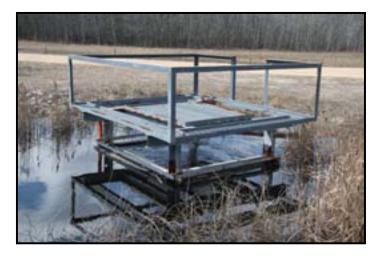
Barrier 1. Ducks Unlimited control structure at the upper end of Hatchery Drain at Goulet Lakes.

Although located at the upper reach of Hatchery Drain, this control structure appears to be a complete barrier to all fish movement. Northern Pike, Yellow Perch and White Sucker would likely utilize the habitat upstream for spawning or as nursery habitat. Identified as barrier 4 on habitat featured map (Appendix A-3)

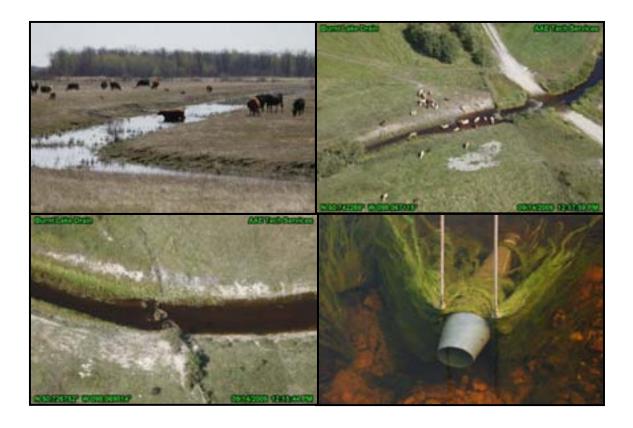
Turbidity was one of the major concerns within the waterways. Livestock grazing, causing damage to riparian zones along banks, increased erosion and created higher sediment loads within the waterways. Figure 12 is a photograph illustrating the difference between a non-turbid waterway and a turbid one. Fish, most likely prefer non-turbid waters. The turbidity within the main stem of Hatchery Drain was 4.17 NTU, while the turbidity was 0.12 NTU flowing out the vegetated side tributary.

Figure 11. Livestock grazing, a common site within the tributaries of the Swan Creek Watershed may lead to nutrient and sediment loading within the aquatic environment.

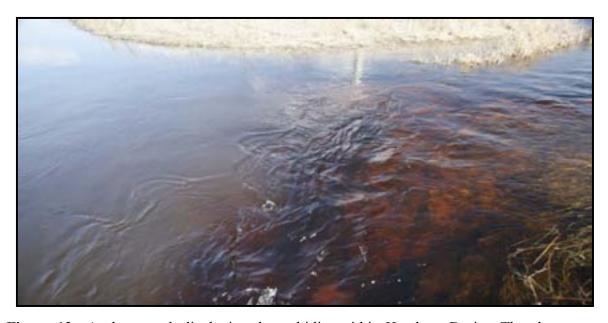
Figure 12. A photograph displaying the turbidity within Hatchery Drain. The clear water is flowing from a vegetated ditch.
