LAKE FRANCIS WATERSHED RIPARIAN AND AQUATIC ASSESSMENT

**A Report Prepared by
Mark Lowdon M.Sc.
AAE Tech Services Inc.**

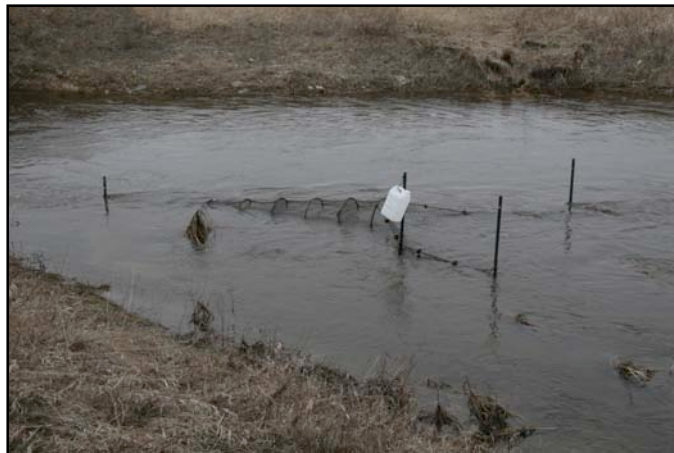
Sampling began on April 12th and commenced on May 13th. The hoop-nets successfully deployed were 1.2 m in diameter and constructed of 1.85 cm² nylon mesh. Attached to the first hoop of each net were two, 4.5 m wings, used to guide fish into the traps. The hoop-nets were

set and monitored at random locations through out the study area. Captured fish were placed in a holding tank, identified, sex and state of maturity assessed, and fork length (FL) measured. Digital photographs of representative specimens were also taken. All fish were released unharmed. Sampling was conducted to gain a better understanding of which tributaries were being utilized by fish during the spring movements and also to identify important spawning

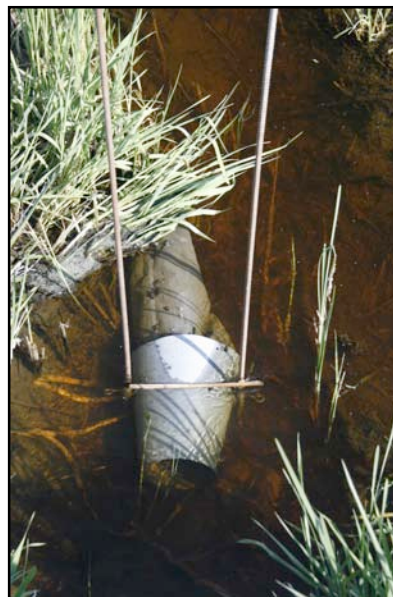
Larval drift nets were used to capture larval fish that successfully hatched within the Lake Francis Watershed during the spring of 2010. Each drift net was positioned on two rebar rods that were embedded into the stream bottom. The traps were positioned into the flow as shown by in the photograph. The surface area of each trap opening was 0.02 m² and the water velocity (m/sec) and the lengths the traps were set was recorded. The traps were set approximately 0.30 m below the water surface in the faster moving water, when possible. Larval fish drifting downstream enter the funnel opening on the upstream end of the trap. Once inside, the larval fish are unable to escape. The mesh size of the nitex mesh lining is 0.250 mm. Larval fish collected were preserved in 10% formalin and then identified using a microscope with 40X magnification. The larval key entitled Identification of Larval Fishes of the Great Lakes Basin with Emphasis on the Lake Michigan Drainage (1983) by Nancy A. Auer was used to confirm identification.

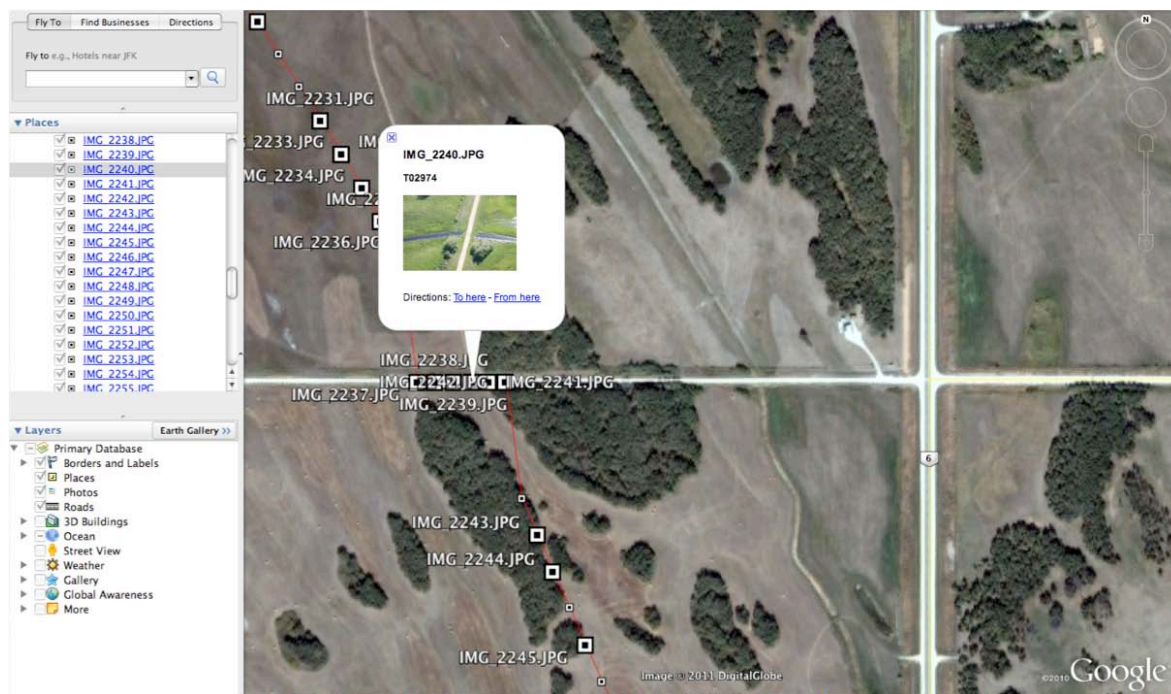
Figure 7. A computer screen image of the flight path track and associated photographs of a selected reach using Google Earth software.

Representative aerial photographs of each tributary can also be found within Appendix B. These photographs were compiled to provide a general summary of the habitat found along each corridor of the seven main tributaries of the Lake Francis Watershed. All photographs were captured at an altitude of approximately 500 feet.

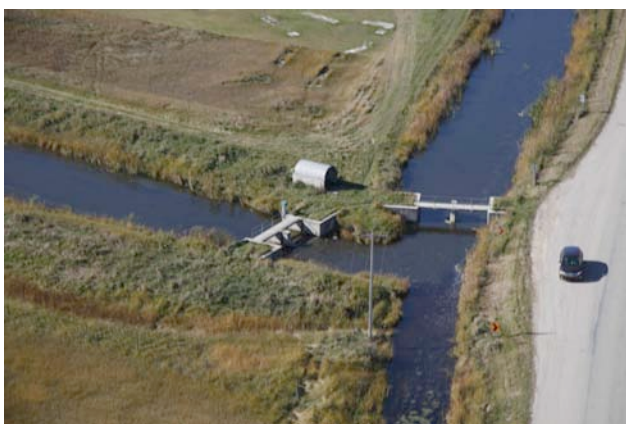
Barrier 1. Stoplog control structure at the Lake Francis outlet channel.

Built in the 1960's, this control structure was designed to regulate water levels within Lake Francis. Under low flow conditions, this structure is likely a complete barrier to all fish movement. Upstream habitat typically would be utilized by Northern Pike, Yellow Perch and White Sucker (to name a few) for spawning, feeding and/or a nursery. Identified as barrier 1 on the habitat featured map (Appendix A-5)

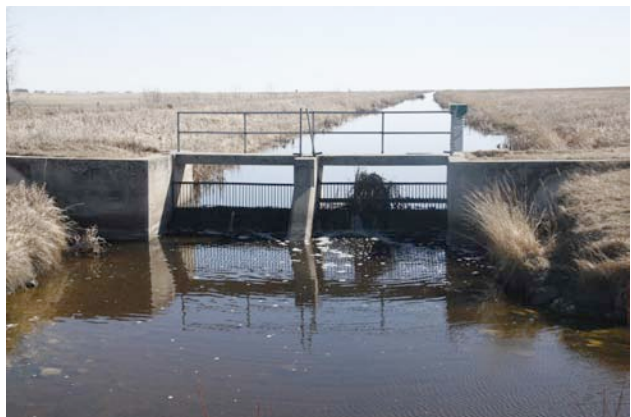
Barrier 2. Screen installed on the Lake Francis stoplog control structure.

The screen or gates located on top of the stoplog control structure at the Lake Francis outlet were installed in 2007 by the LFWMA committee to prevent Common Carp from entering the lake. As previously stated, Carp may degrade habitats in which they inhabit. Unfortunately, this barrier also restricts most native fish species. The barrier is identified as barrier 2 on the habitat featured map (Appendix A-5)

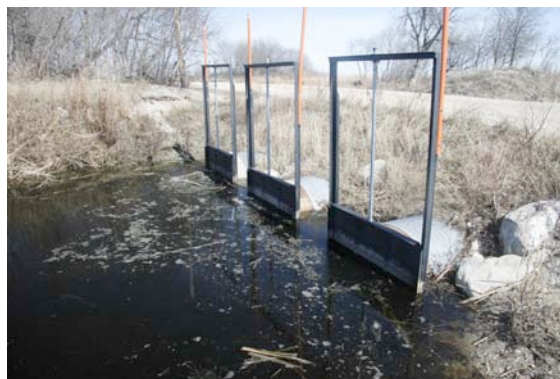
Barrier 3. Screened culverts on Lambert Creek.

Lambert Creek is a small creek (0.9 km long) that connects Lake Francis to Lake Manitoba. The creek only flows when Lake Francis is experiencing high water levels. Similar to the screens located on the stoplog control structure, these screens were designed to prevent Carp from entering the lake. The barrier is identified as 3 on the habitat featured map (Appendix A-7).

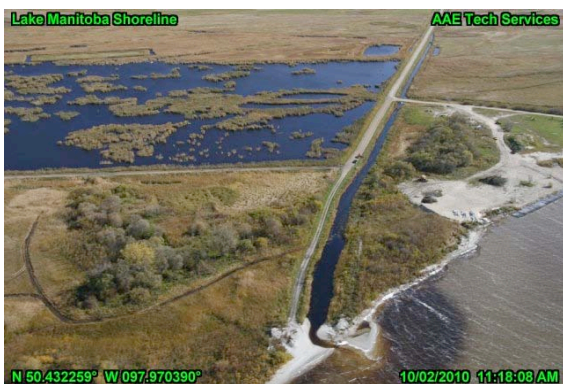
**Barrier 4.** Gravel bar located at the mouth of Laurentia Drain.

During ice or wave action, the gravel bar at the mouth of the creek formed a complete barrier to fish movement. This barrier was likely removed (notched by heavy machinery) after the area received heavy rain during June or July. It is likely to impede fish movement in subsequent years. The barrier is identified as 4 on the habitat featured map (Appendix A-4).

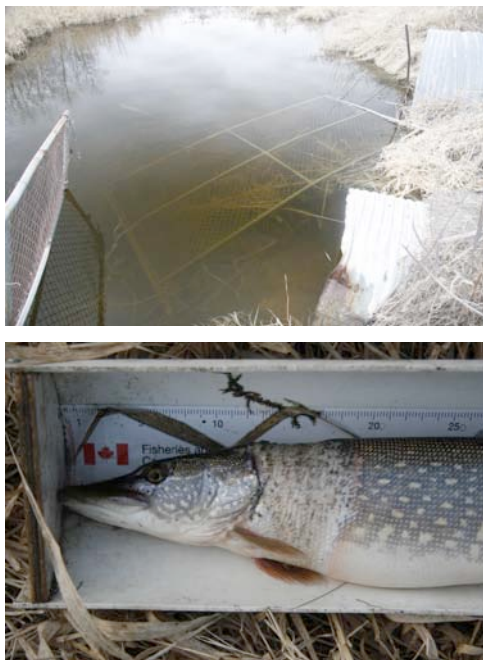
Barrier 5. Beaver gates positioned within Swamp Lake Drain.

Within Swamp Lake Drain, two fences were observed downstream of the culvert crossing PTH 518. These gates apparently were used to prevent beavers from plugging up the culverts and restricting their movements. However, when the gates were not in use they were left within the channel during the spring runoff. A female Northern Pike (noted in the picture) was entrained within the fence. Although, this barrier is only temporary and was likely not intended to impede fish movement, it does however provide a temporary barrier. The barrier is identified as 5 on the habitat featured map (Appendix A-2).

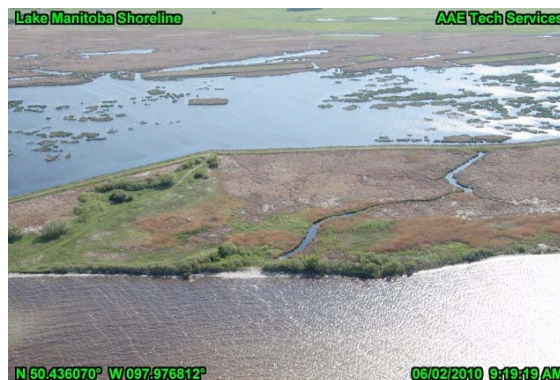
Barrier 7 and 8. A gravel bar and gated culverts prevent fish from entering Ennis Marsh.

Similar to Laurentia Drain, a gravel bar has formed along the Lake Manitoba shoreline. This barrier restricts fish from reaching Ennis Marsh and potentially valuable nursery or spawning habitat. Gated culverts also located on Ennis Marsh, provide an additional barrier to fish movement. Barrier is identified as 7 and 8 on habitat featured maps (Appendix A-3).

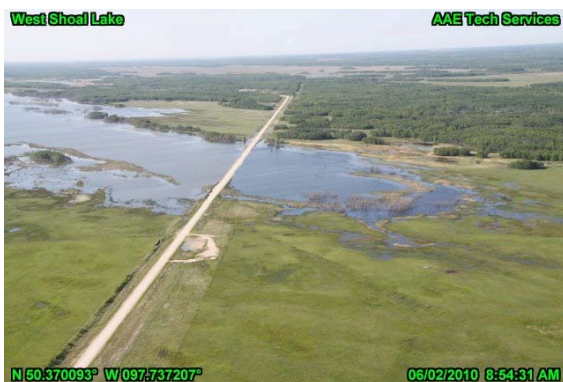
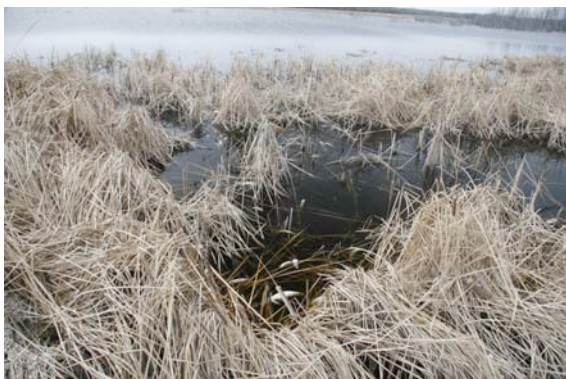
Barrier 9. PTH 518 road crossing the northwest tip of West Shoal Lake.

The northwest tip of West Shoal Lake is divided by PTH 518. Culverts crossing along the road allow fish to reach this divided section. However, fish are not always able to make it back to the lake to overwinter. In the spring of 2010, hundreds of dead fish were observed including Northern pike, White Sucker, and Black Bullheads. They died as a result of either winterkill via oxygen depletions or as a result of the water body freezing to the bottom.

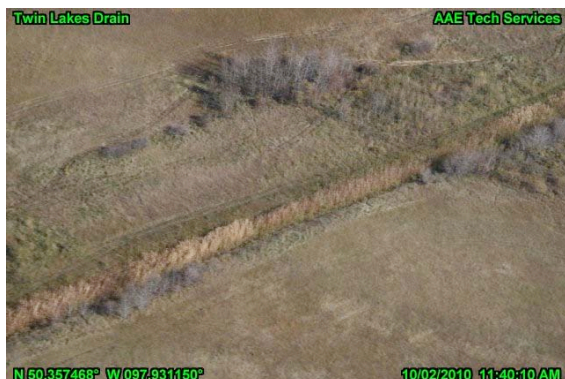
Barrier 10. Dense vegetation along Roy's Drain.

There are many sections along the drain where vegetation appears to choke off the waterway, impeding fish movements. The sections can be view on the habitat featured map (Appendix A-5).

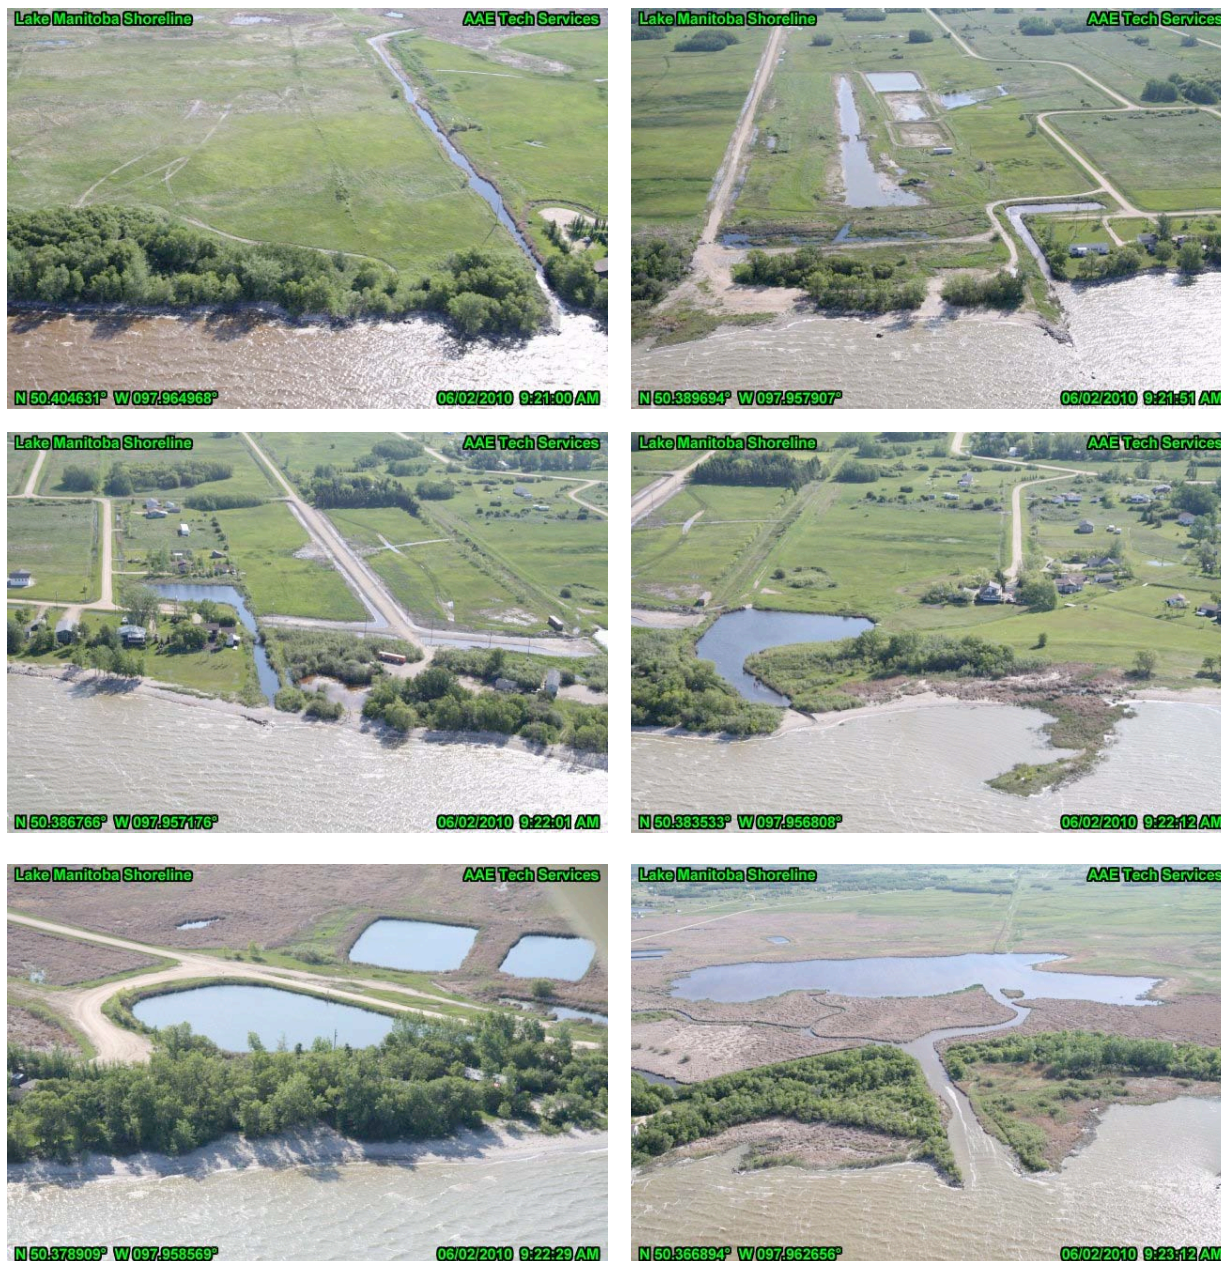
Figure 12. Photographs taken of sloughs and marshes located along the Lake Manitoba Shoreline potentially leading to nutrient loading within Lake Manitoba.

Along the Lake Manitoba shoreline, several of the waterbodies connected to the lake could potentially be sources of nutrient loading. Discussions with members of the West Interlake Watershed Conservation District brought it to our attention that several old retaining ponds and old manure piles were thought to be leaching into Lake Manitoba, adding to increase nutrient levels within the lake. Below are a number of photographs illustrating the types of habitats described above. Additional research is needed to address some of these issues.
